Manhole Inspection Summary

Manhole # S43CC_035MH

Location Address: **1715 E EAGER ST**

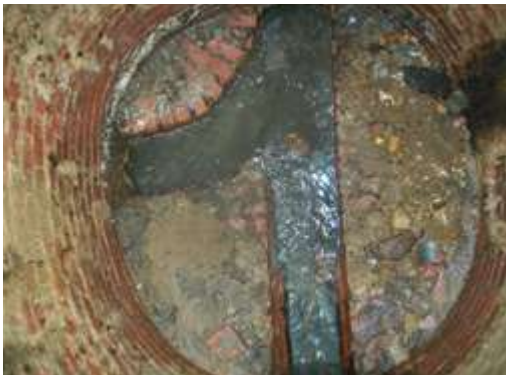
Comments **DEBRIS REMOVED BY VAC-CON, FLUSHED PIPES FROM MANHOLE; FRAME IS NOT ABOVE GRADE - FINISHED PAVING GRADE NOT IN PLACE**

POST CLEANING

PRIOR TO CLEANING

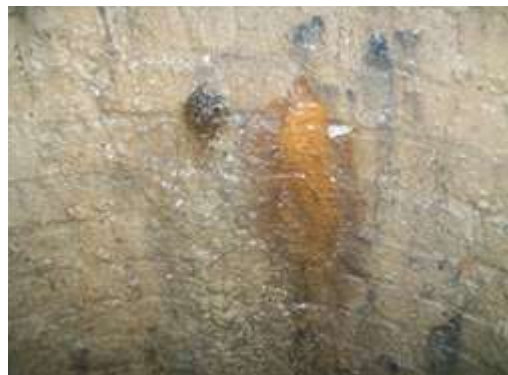
Defect 2

Infiltration: ☐ None ☐ Joint ☐ Cracks ☐ Mortar ☐ Roots ☒ **Wall**

INFILTRATION @ BARREL WALL

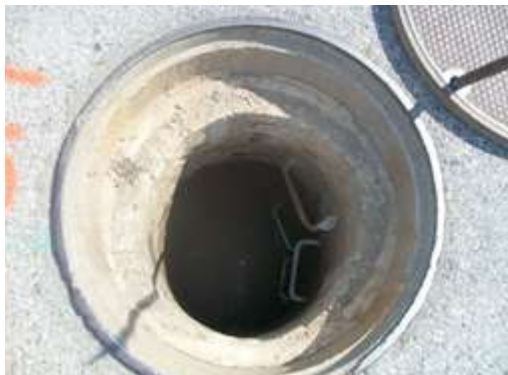
Defect 1

Offset: **4** (in.)

FRAME OFFSET

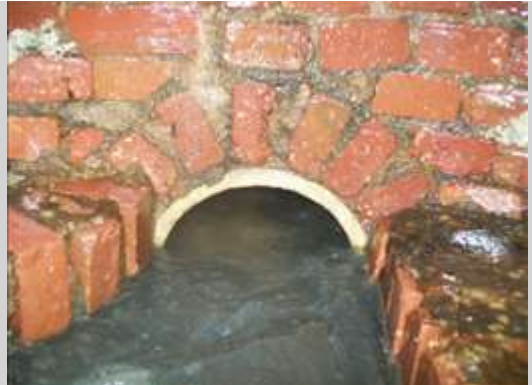
12 O'Clock Outflow

10 in. Circular Gravity Sewer
Pipe Out @ 12 O'Clock

Pipe Height: **10.8** (in.) Rod and Bar (Angled)
Pipe Material: **Clay** ☐ Pipe Lined
Invert Depth: **13.10** (ft.) Flow Characteristics: **Slow**
Deposits: ☒ None ☐ Mud ☐ Sludge ☐ Debris ☐ Grease
Silt Depth: **0** (in.) Deposits Extent:
Infiltration: **None** Pipe Seal Cond: **Sound**

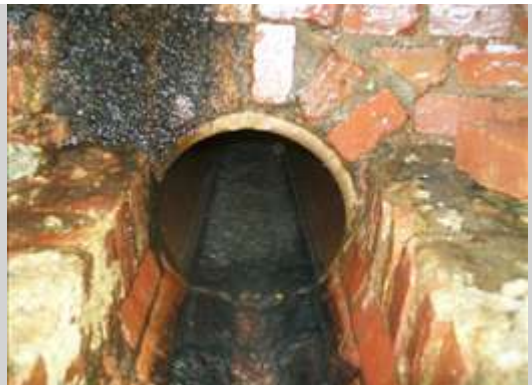
6 O'Clock Inflow

10 in. Circular Gravity Sewer
Pipe In @ 6 O'Clock

Pipe Height: **10.8** (in.) Rod and Bar (Angled)
Pipe Material: **Clay** ☐ Pipe Lined
Invert Depth: **12.81** (ft.) Flow Characteristics: **Slow**
Deposits: ☒ None ☐ Mud ☐ Sludge ☐ Debris ☐ Grease
Silt Depth: **0** (in.) Deposits Extent:
Infiltration: **None** Pipe Seal Cond: **Sound**

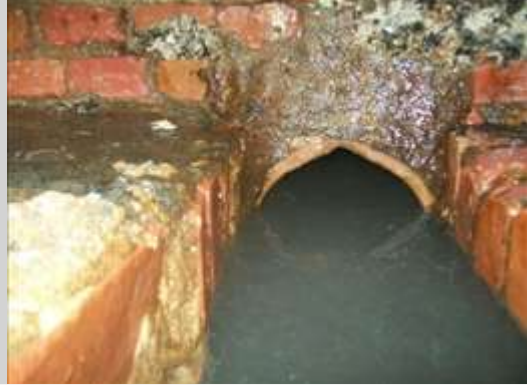
9 O'Clock Inflow

8 in. Circular Gravity Sewer
Pipe In @ 9 O'Clock

Pipe Height: **8.4** (in.) Rod and Bar (Angled)

Pipe Material: **Clay** ☐ Pipe Lined

Invert Depth: **12.89** (ft.) Flow Characteristics: **Slow**

Infiltration: **None** Pipe Seal Cond: **Sound**
